## **Building Report on Royal property**

**Address- 600 Orere- Matingarahi Road Orere Point**

CERTIFICATE OF PROPERTY INSPECTION

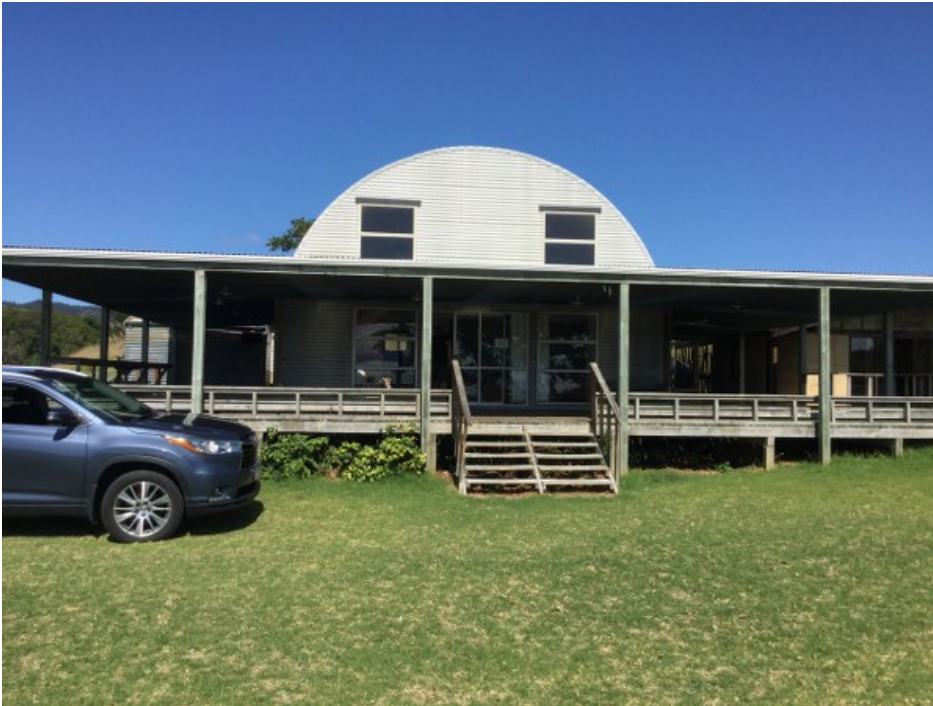
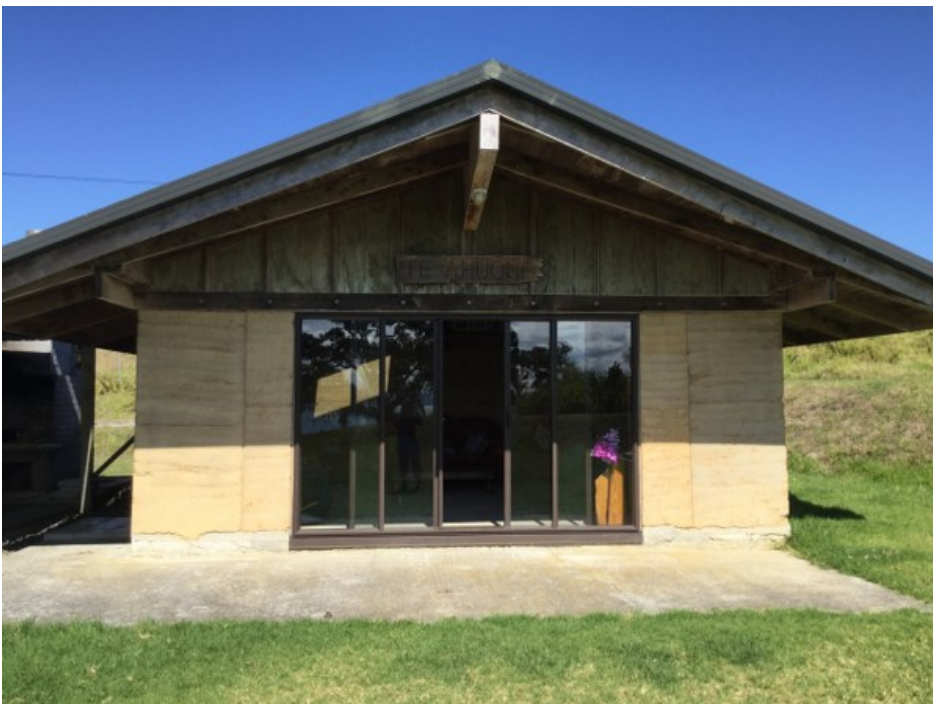
1 front view

The second building is a Rammed Earth construction on a full concrete slab foundation. This building has a code Compliance certificate as a storage shed facility. This building has a large overhanging corrugated iron roof. The large overhangs are for weather protection to the rammed earth walls.

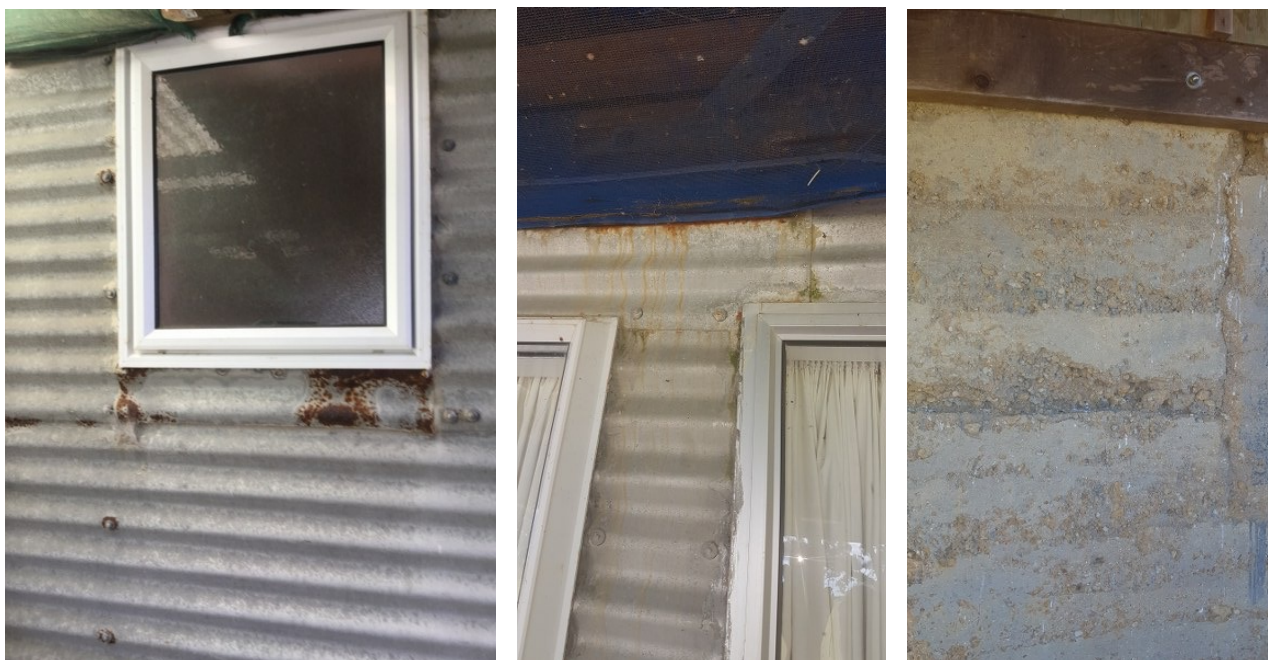
The Exterior is mostly in good condition. There is some rust to the right side that needs to be treated with “Rust Converter” then a “Rust Primer”.

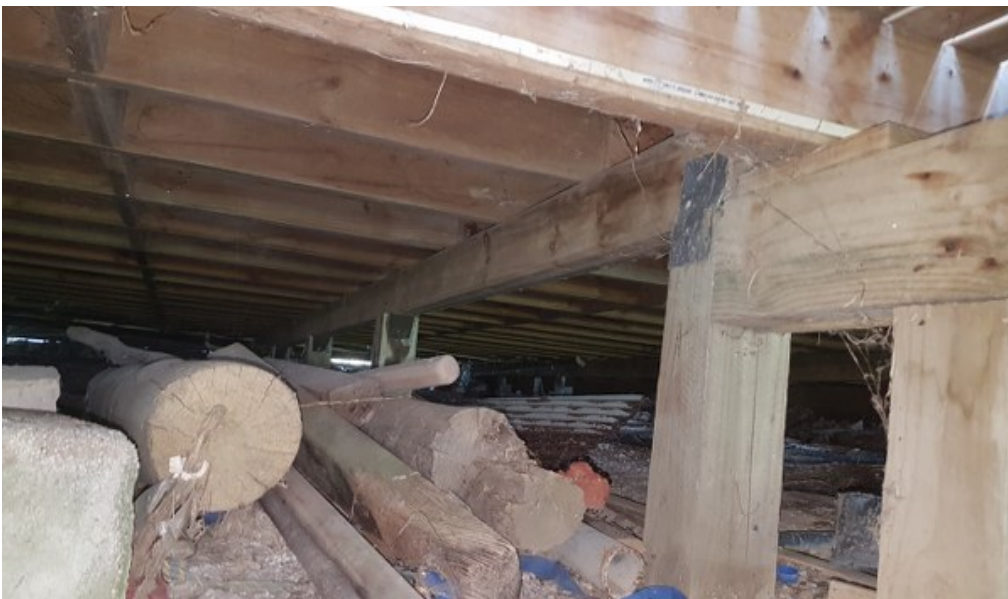
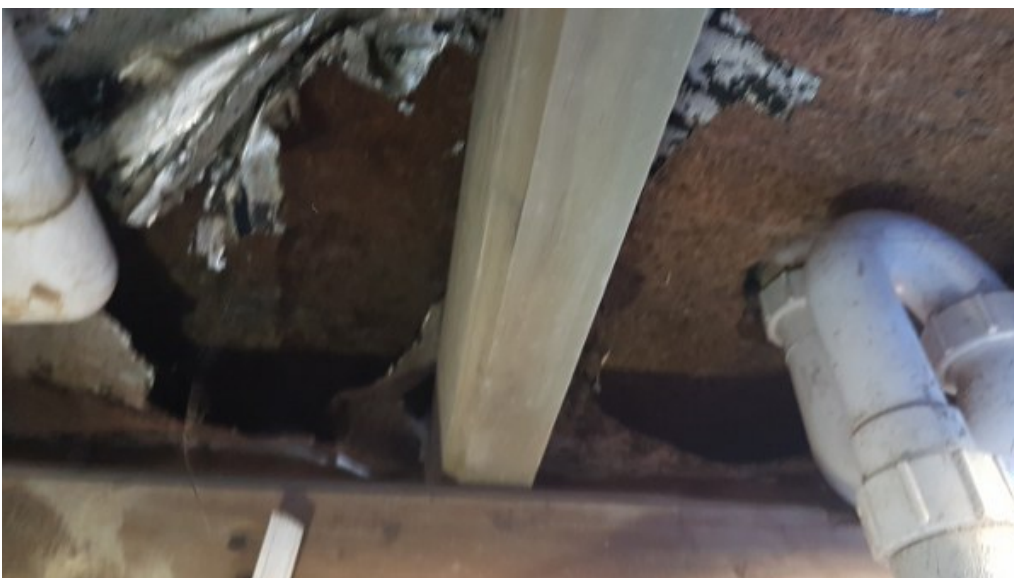
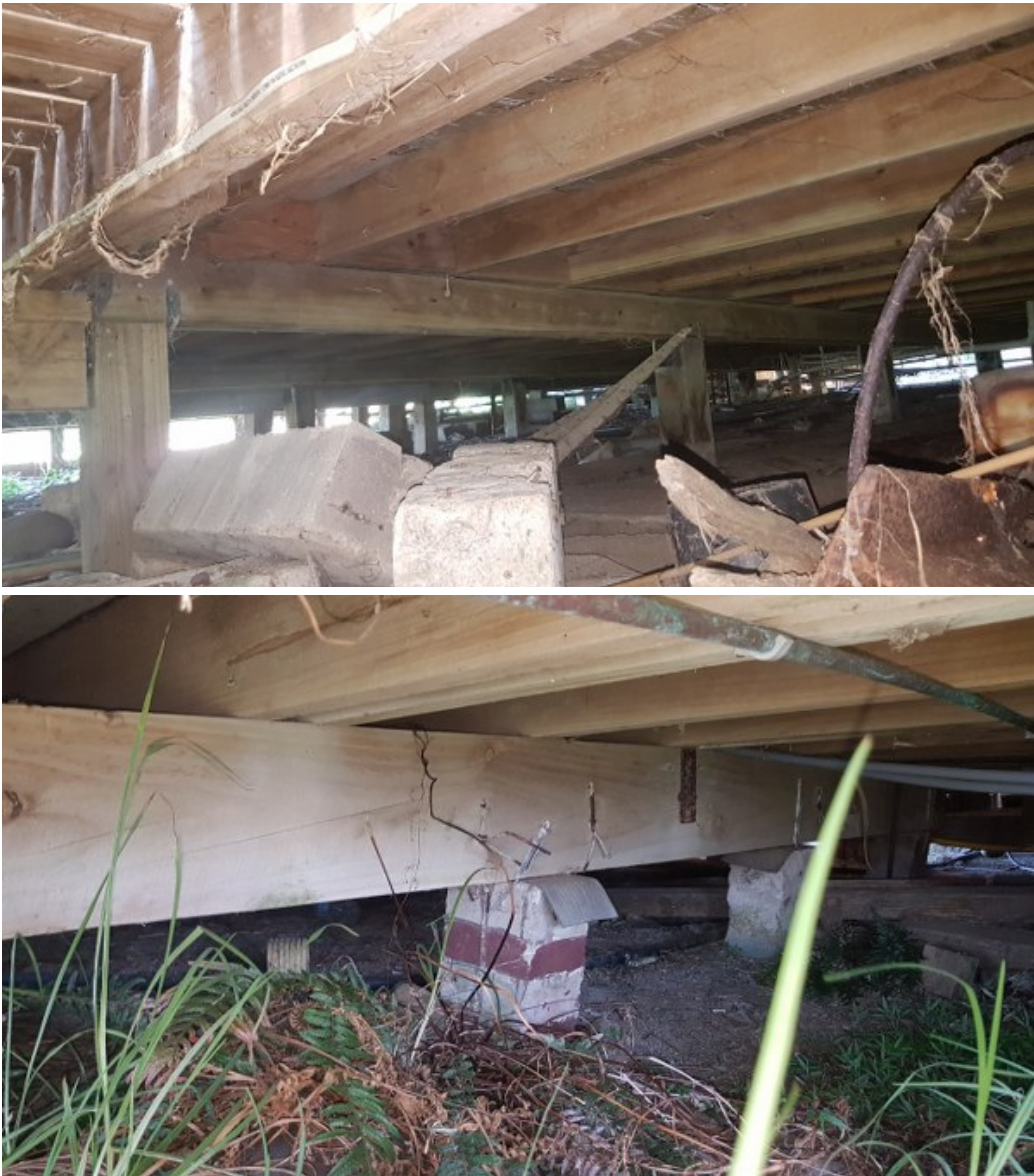
The foundations are in good condition. The underfloor foil insulation is disintegrating. It is highly recommended the insulation is upgraded with Polyester fibre. This will improve the warmth of the building in winter and cool in summer. Due to the site being in a very high wind zone this insulation will need to well secured in place and base boards will add to the protection of the insulation.

It is recommended the basement be enclosed with base boards that have a 25mm gap between the board. Two access doors will be advisable for ease of maintenance one being close to most of the underfloor plumbing.

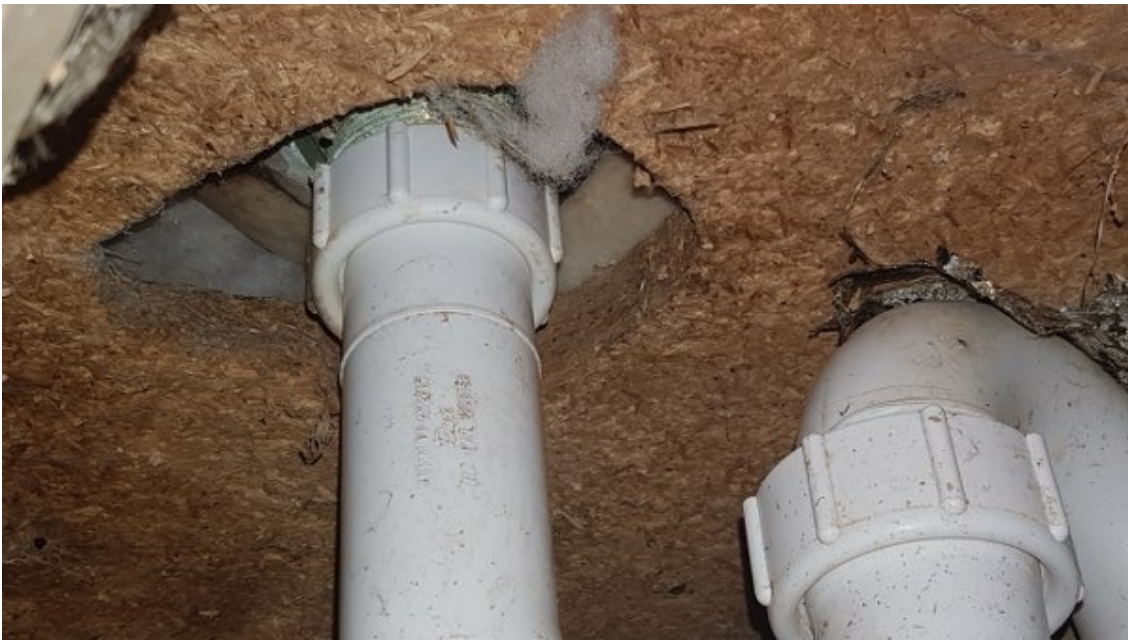
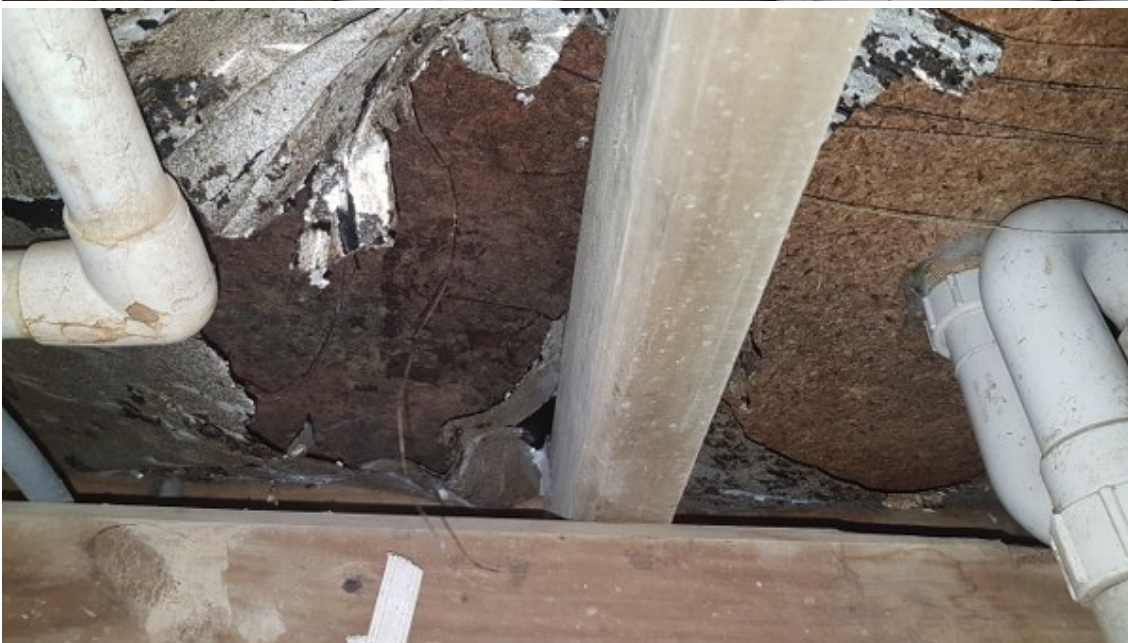
The particle board flooring under the bathrooms is in very poor condition due to wet decay. The flooring to the service rooms need to be replaced with treated plywood. Any repairs and replacement materials must be up to current building code standards as near as reasonably practical. Replacing the floor will require the service rooms to be striped out and rebuilt. This is an opportunity to upgrade the service rooms to modern standards. The rooms

will require wet area wall linings, insulation to external walls and any substandard plumbing replaced. If it is decided the mezzanine is to be used for sleeping, the ceilings will need to be lined with Fire rated linings and insulation for protection of spread of fire to mezzanine floor.

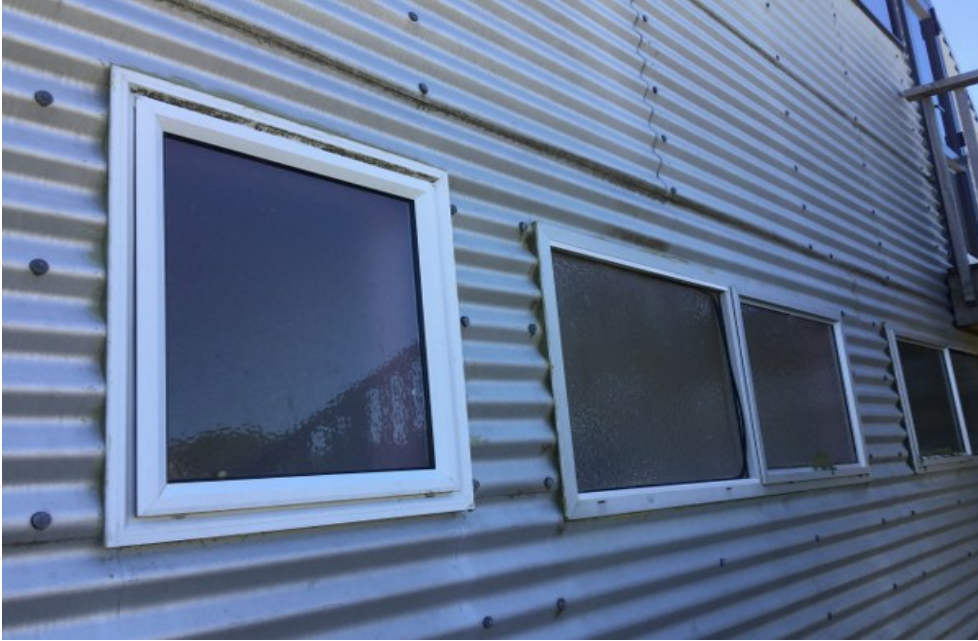
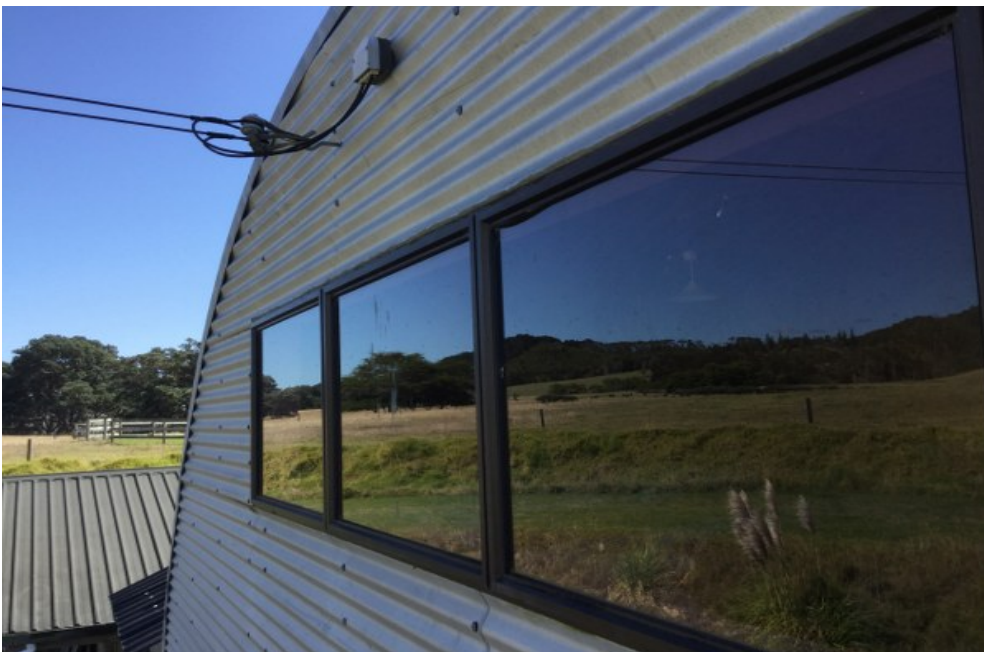
This building was built when it was legal to install windows without head flashings. Where the code required the owner to replace the sealants every 5 years. This was a very bad decision by the Building Industry Authority and this building has suffered constant leaks around doors and windows from this.

It is highly recommended this problem is fixed with a Registered builder installing made to size head flashing and side flashings to all doors and windows. Being a very high wind zone quality flashings are extremely important for this building.

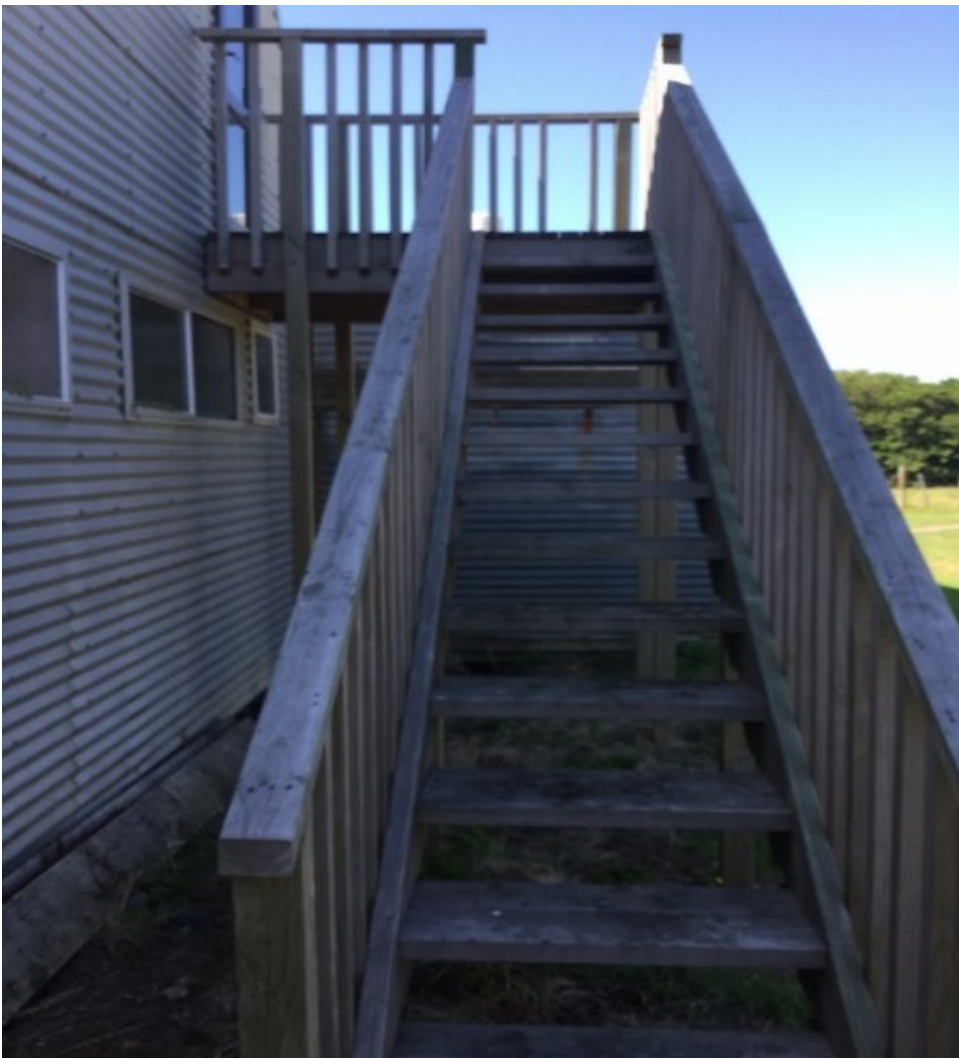
There are several short stairs to the main deck and a stair and landing for the back door to the mezzanine. The stairs to the front deck are sagging due to over span of the tread timbers. It is recommended these stairs have

additional runners fitted under them. The other stairs are in acceptable condition.

The ramp decking is in poor condition and needs replacing then a Deck Seal applied.

To ensure these stairs stay safe it is recommended the timbers are washed with “Deck Cleaner” then two coats of “Deck Seal” applied.

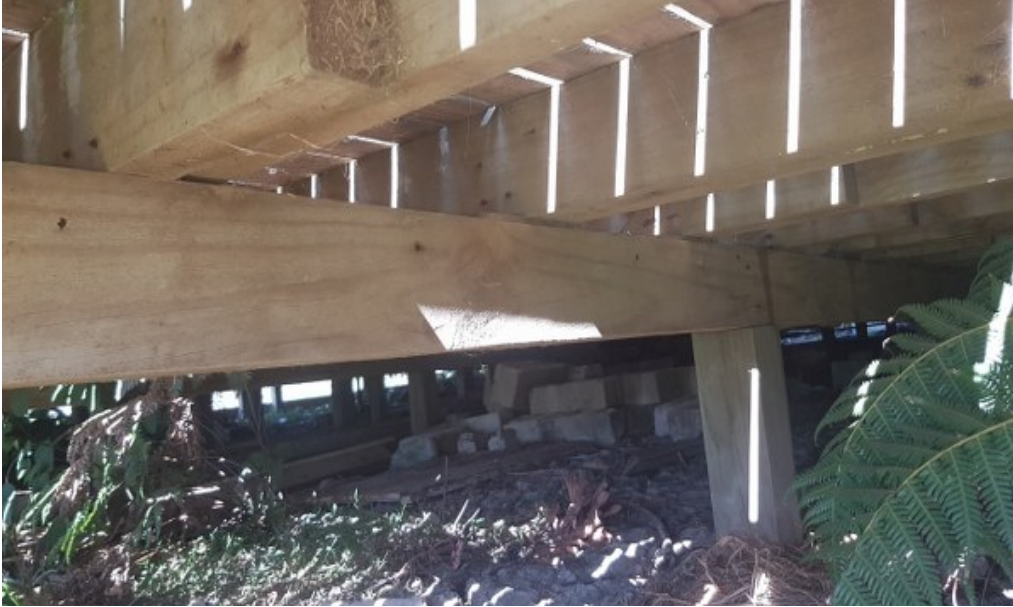
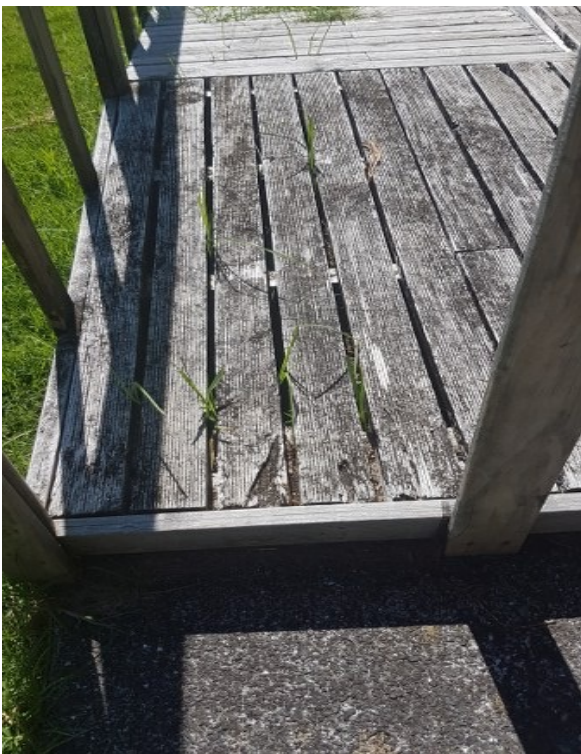
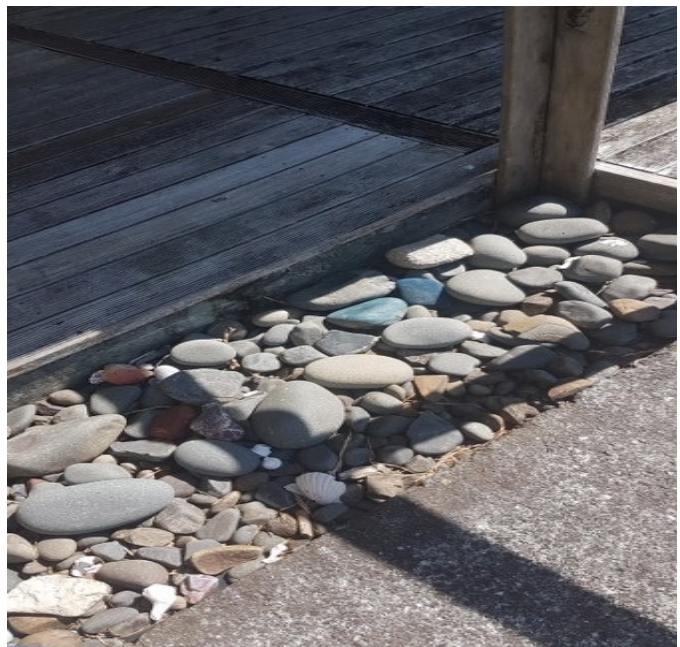
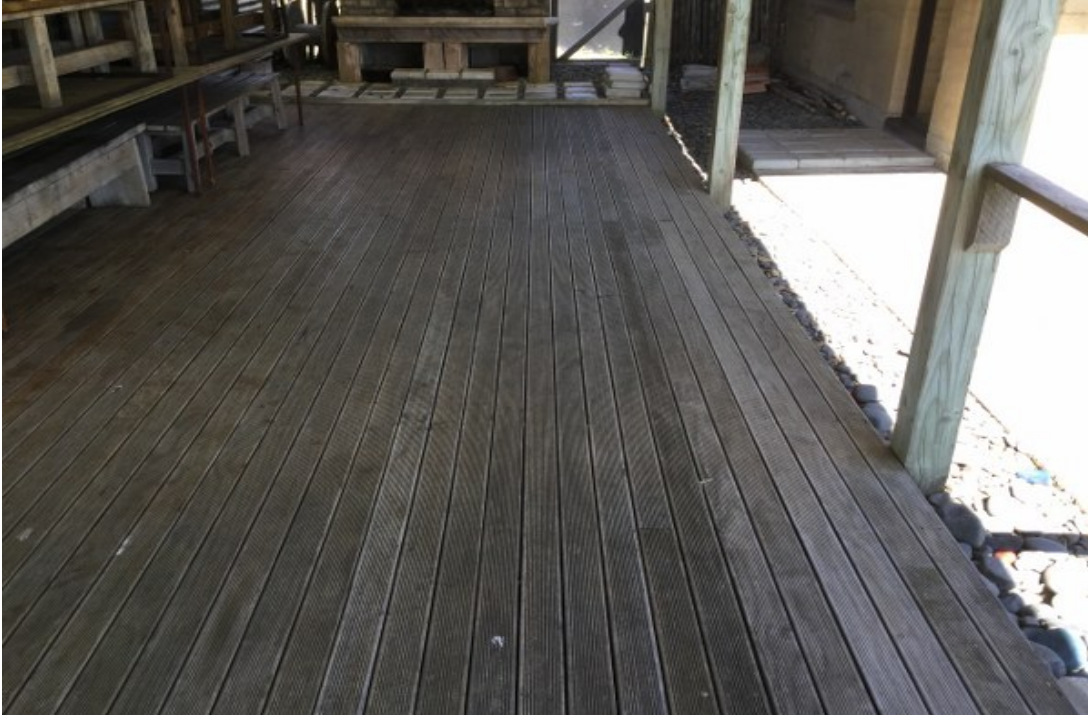
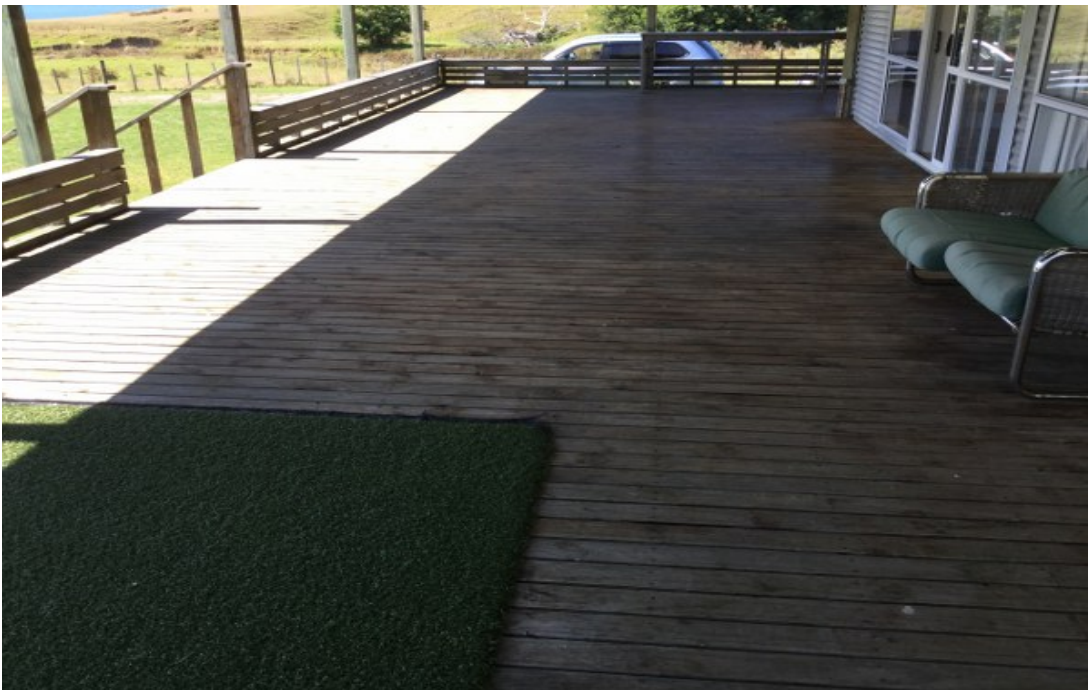
There is however a couple of sections of the deck that have been exposed to the weather and the decking timber to these areas is in poor condition. These are to the side by the ramp and the small section by the utilities shed. Some of the decking timber to these areas will need to be replaced.

The side of the decking on the right has stone against it. This stone needs to be moved away from the decking to allow cross flow ventilation to the underside of this area of decking and to allow the timber to dry out.

The screening hung under the deck roof will need to be removed from nominated escape routes for prevention of fire spread of flame.

The open fire unit at the end of the deck is too close to the pergola roofing. It is recommended the pergola roof is cut back to provide a safe gap from the fire.

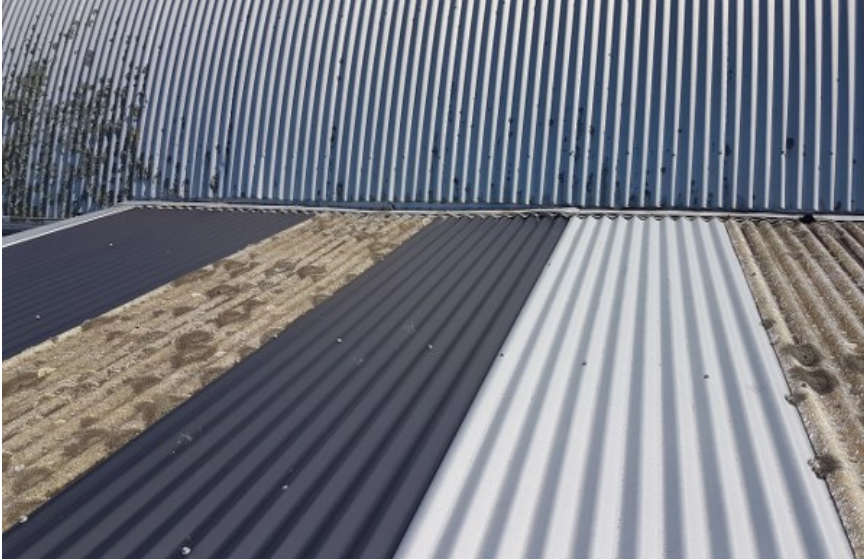
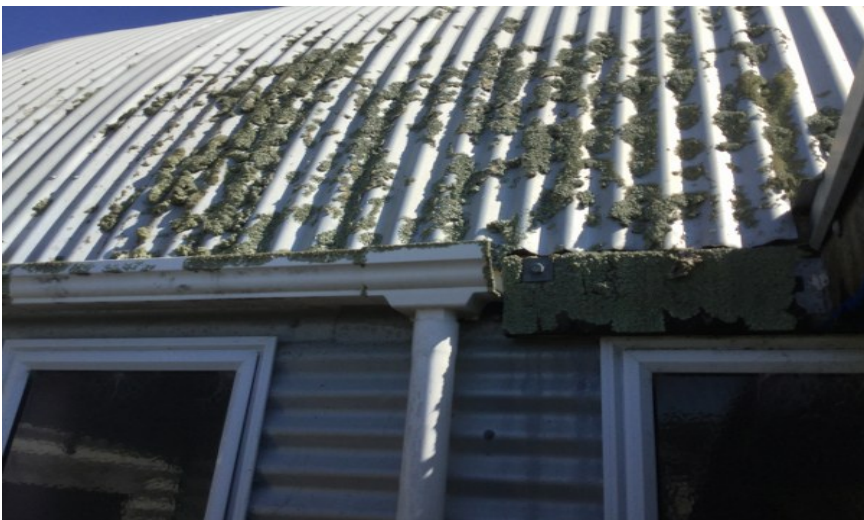
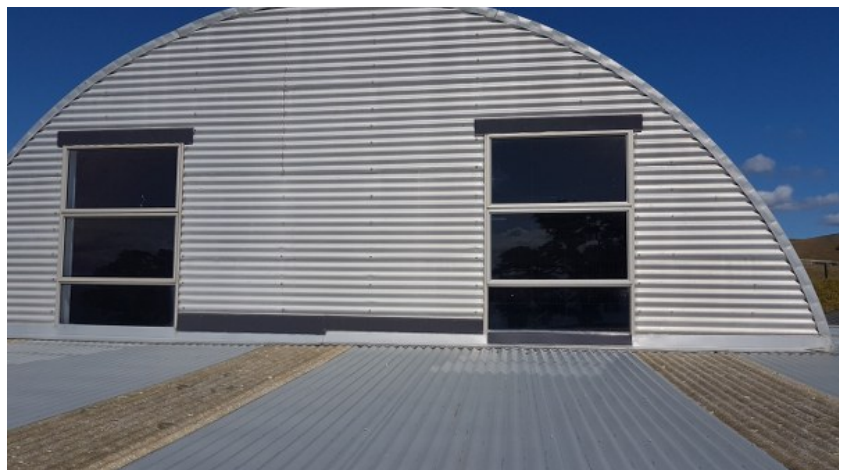
The roof is in reasonable condition but there are some areas where the roofing is lifting. The loose section of roofing need to be fixed securely down with stainless steel roofing screws. There is also moss growth to the left side of the roof. Recommend this section is prayed with a moss removing roof spray. The tank water pipes will need to be disconnected for a week or two after spraying.

The roof to the rammed earth building is in acceptable condition but also needs to be sprayed with roof cleaner.

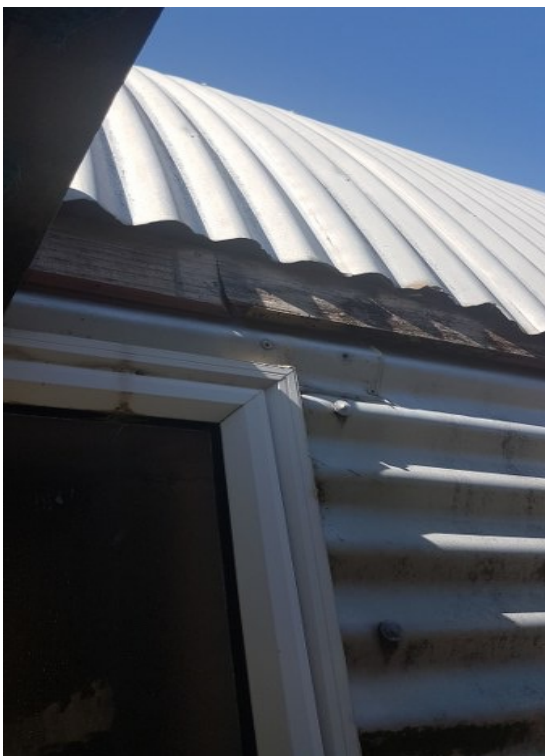
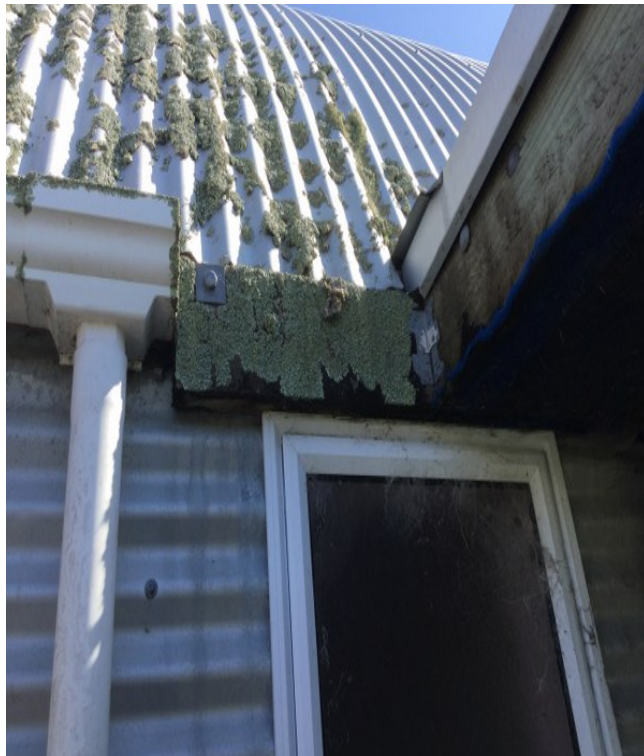
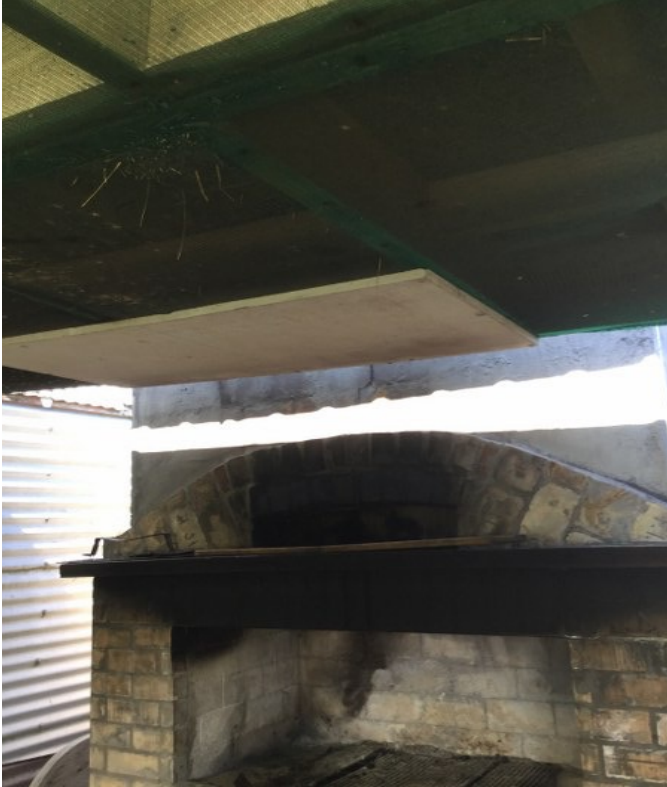
The roof gutters are in acceptable condition. There are two areas where there are no gutters and the roof water runs over the exposed framing, walls and onto the decking. This is causing moss build-up and decay to these areas. A flashing needs to be installed under the roofing and feed into guttering that needs to be installed at these gaps to ensure the areas can dry out. The mould will need to be removed and the expose framing treated prior to fitting the guttering.

The section of roofing above the outside fire needs to be cut back to avoid fire damage. The bear metal roofing to the fire can be extended to provide shelter over the fire.

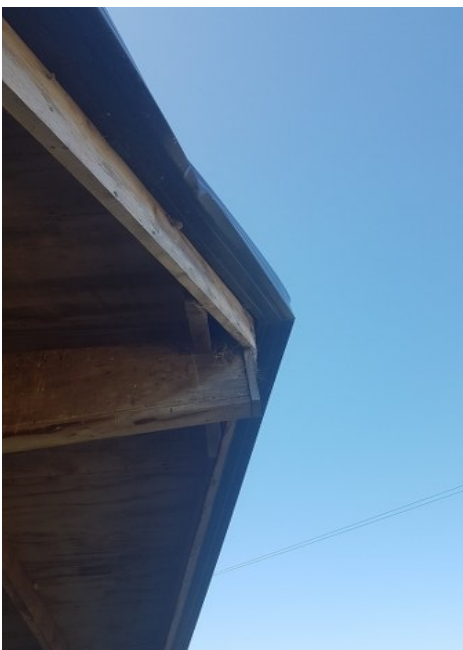
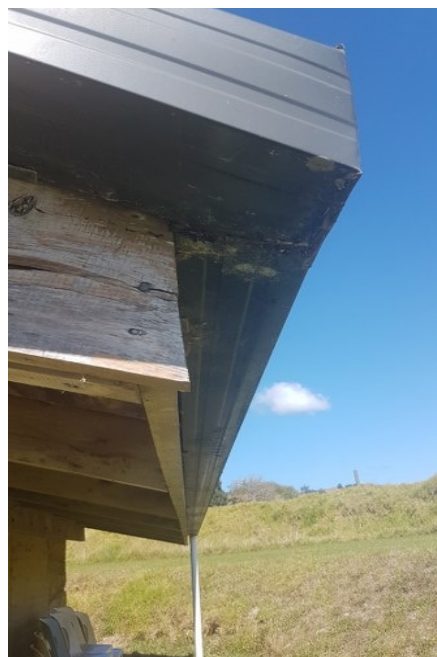
The gutters to the rammed earth building are damaged in several places and have leaks at some joints. Recommend some sections of this guttering are replaced

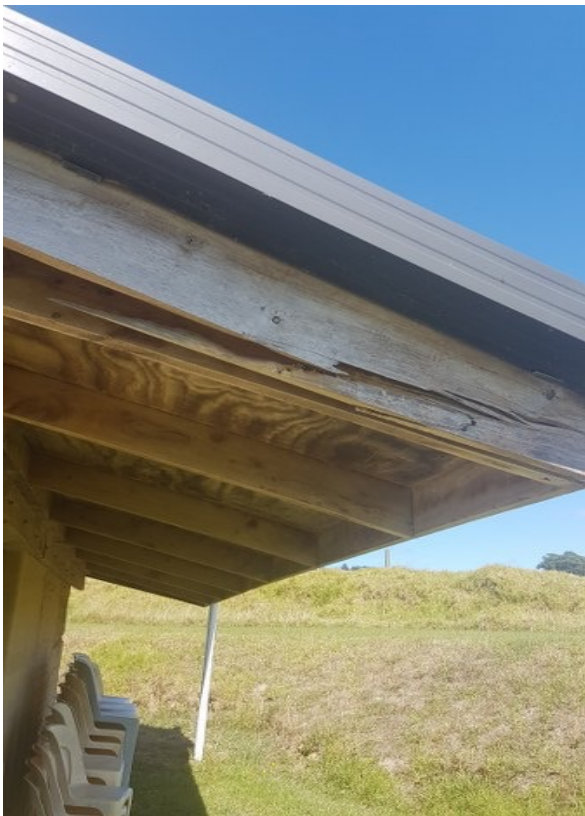
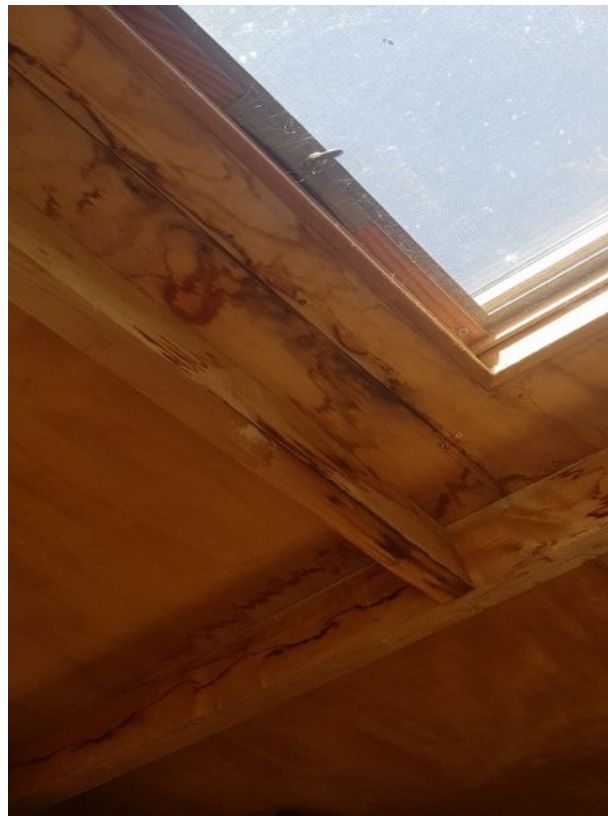
The flying rafter to the front of the rammed earth building is damaged. The damage section needs to be repaired to avoid decay and failure. A part of the roof overhang shows signs of moisture damage. The cause of this needs to be identified and repaired. Recommend further investigation by a registered builder.

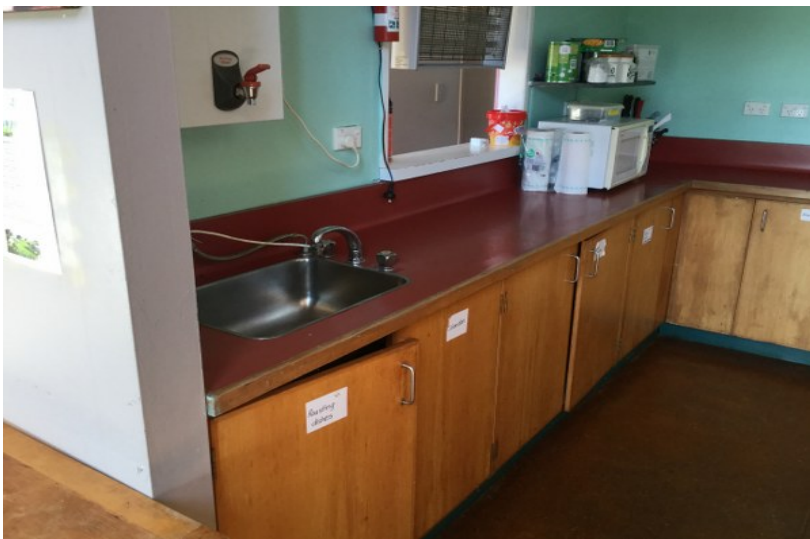
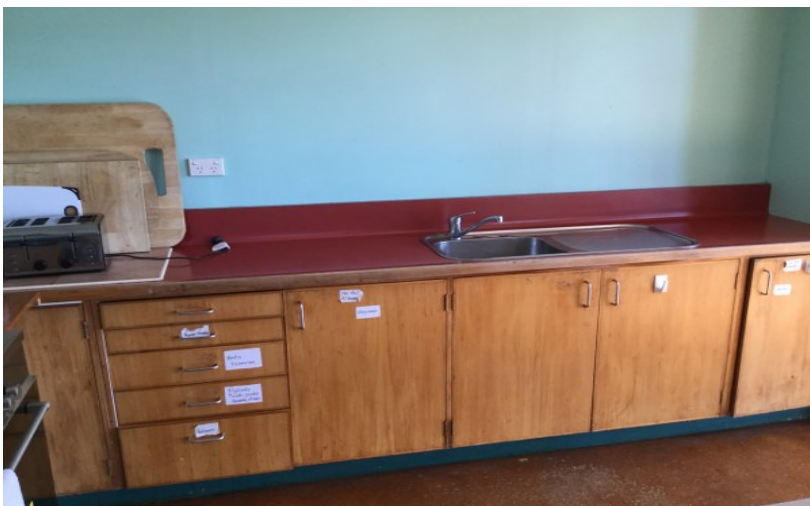
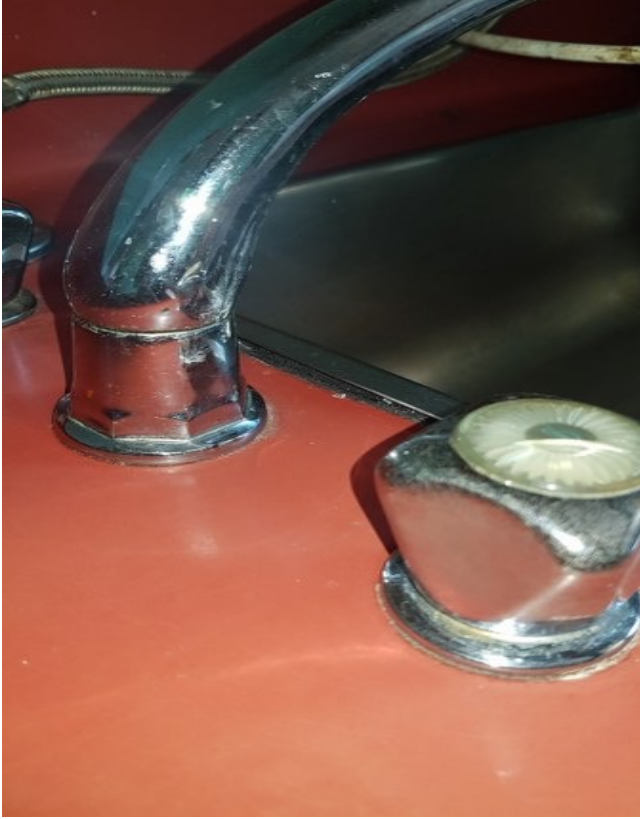
The kitchen has a practical layout with durable cabinets. Installing ducting to the extraction unit is needed and new bench tops as the existing tops has dropped from dampness around the sinks that will be now causing water to seep through to cupboards below. Stainless steel or stone bench tops would be the most practical for this type of kitchen. Also recommend the cupboards are sanded and re-varnished and a commercial vinyl flooring laid to commercial kitchen grade to allow for wet cleaning of the floor.

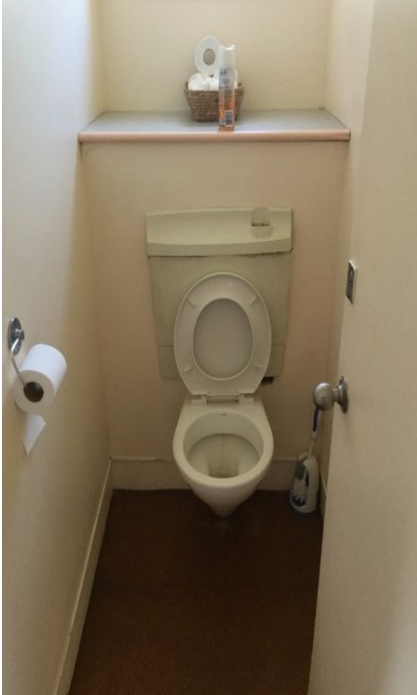
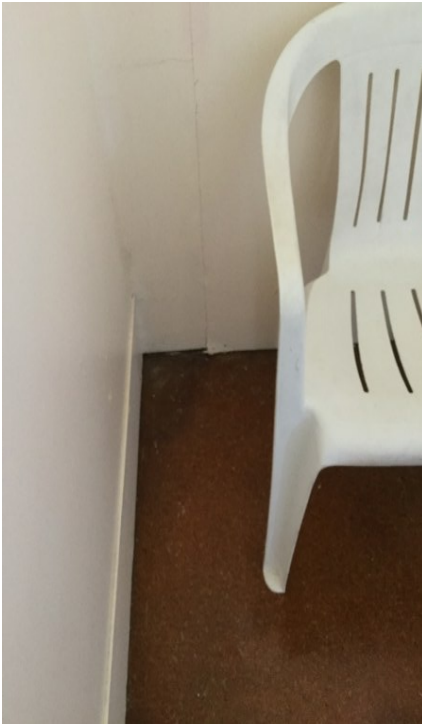
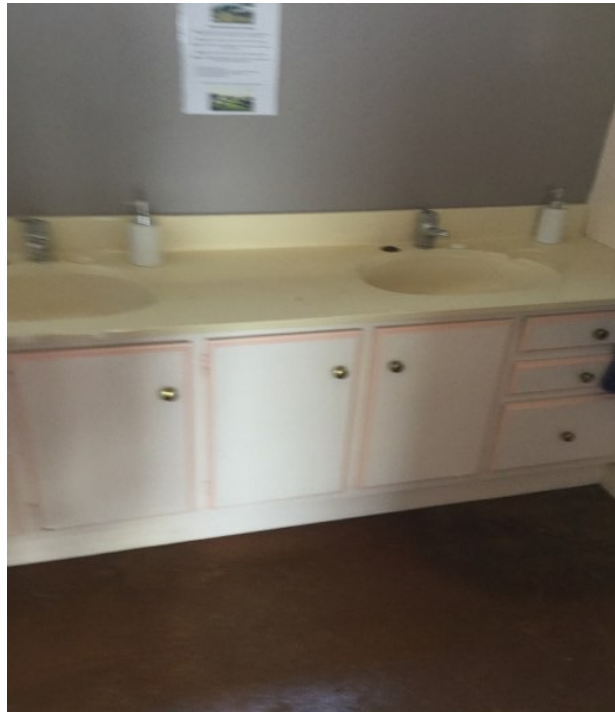
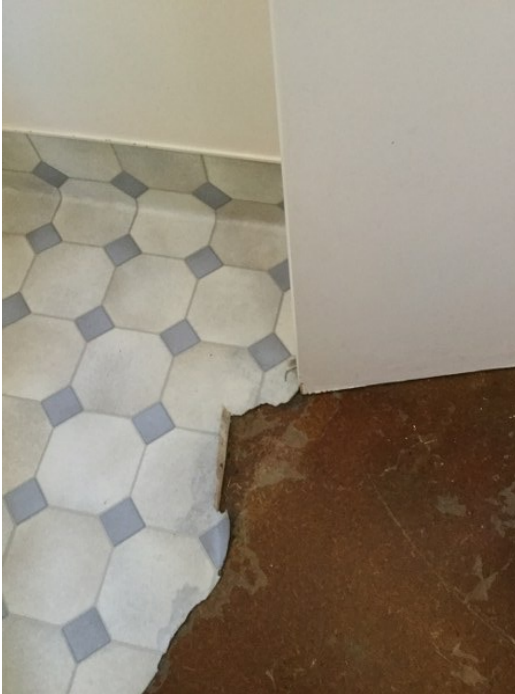
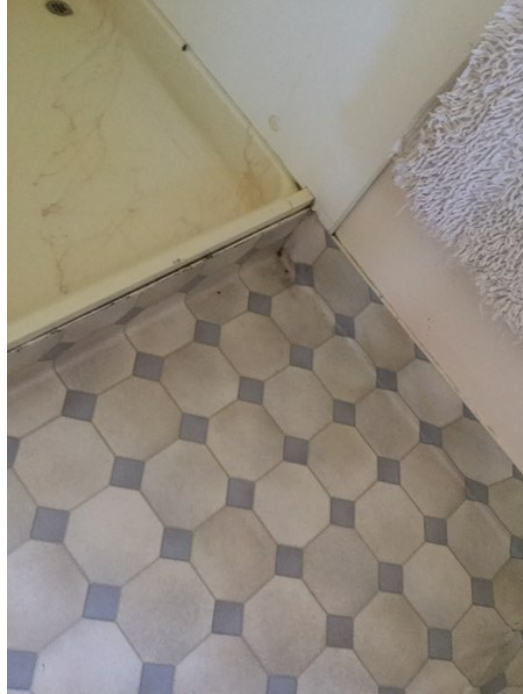
This is an area when most work is needed. The floors have been damaged and there are some wet readings to some areas. With the need to replace the flooring it is an opportunity to upgrade all the ablutions with modern and more durable facilities and surface finishes. It is also a chance to improve the layout to provide additional showers, toilets and wash basins.

All work to the ablutions will be required to be to current building code standards to ensure no future moisture damage can occur. Additional facilities will also require a building consent.

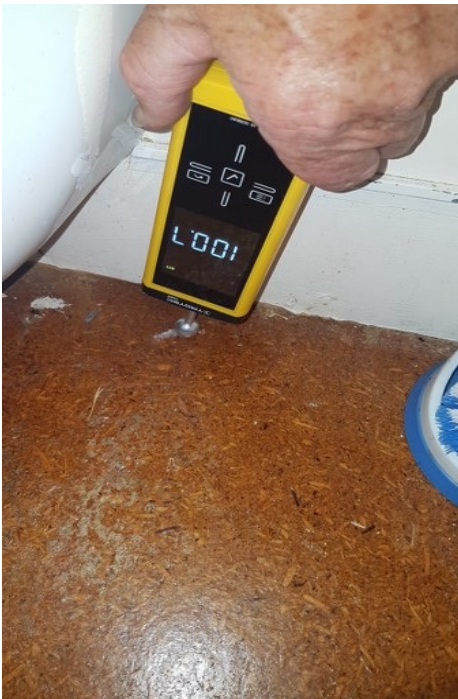
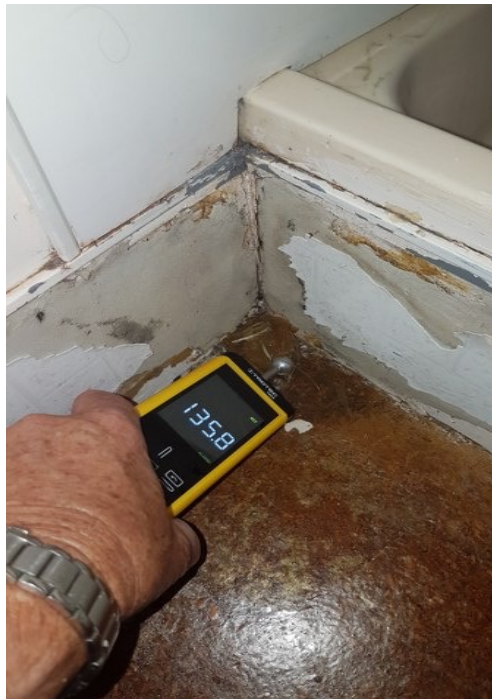
There are high moisture readings to the shower room floor and sides walls of the showers. This issue can be address with the ablutions upgrade and repairs.

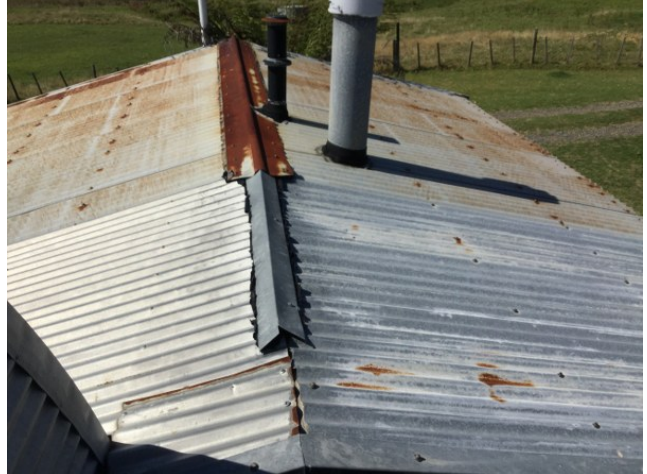
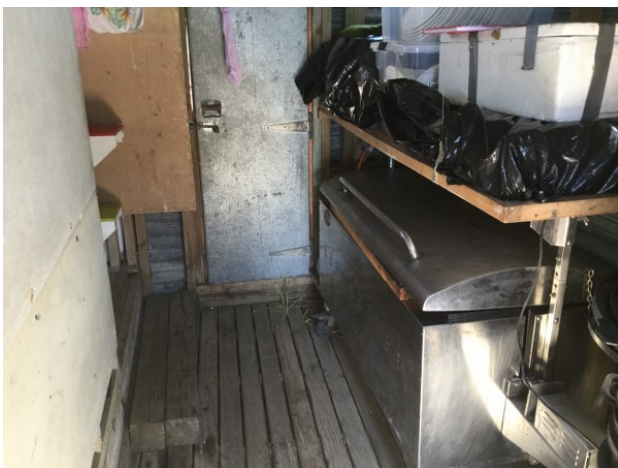
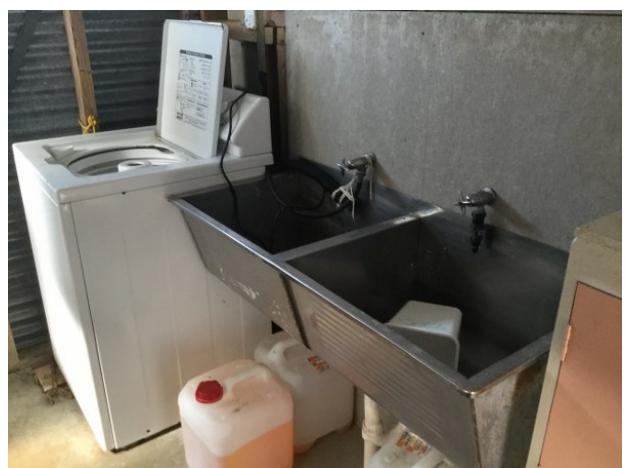
The facilities shed to the side of the main building is in poor condition. The roof is rusty, and the walls are a mix of cheap materials. The shed is on good foundations, but the rest is poorly set up and not very functional. With the shed being attached to the main building it increases the size of the main building fire cell and creates other fire safety issues. Sheds under 10ms do not require building consents.

1. The shed cladding and roof are replaced with more suitable materials
2. The shed layout is re-designed to provide a more compact and secure space for the water treatment and filtration system.

3. The shed storage is better set up for the equipment to be stored and in a separate locked space.
4. The laundry space is renovated to give better storage cupboards including wall cupboard better bench space and functional access for tub/s.

5. The laundry floor and water treatment floors are upgraded with a full water-proof flooring with flood floor drains fitted and retention threshold at the doors

6. The walkway roof and wall are removed to ensure an open space between shed and main building. Then the walkway raised to shed floor level.
7. A Clear-light roof is fitter over the walkway to satisfy fire separation standards.

8. The roof is fitted with full length gutters to stop water damage to walls and decking.
