## **Building Report on Royal property**

**Address- 600 Orere- Matingarahi Road Orere Point**

CERTIFICATE OF PROPERTY INSPECTION

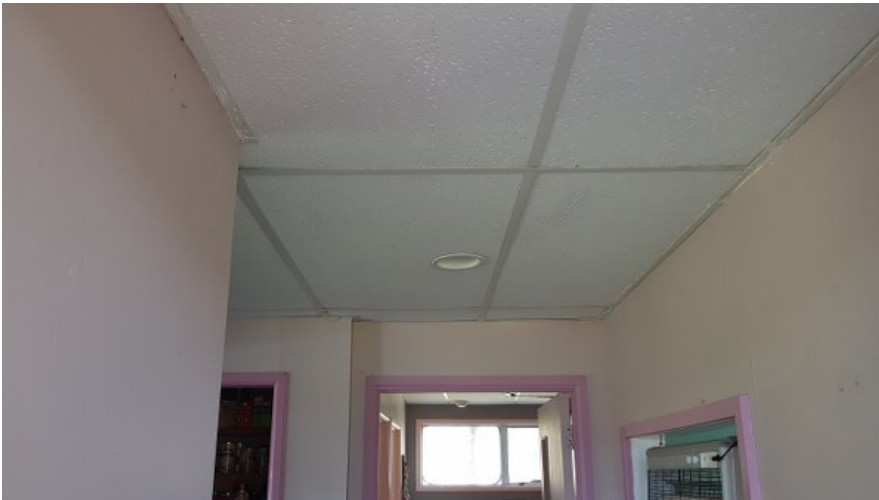
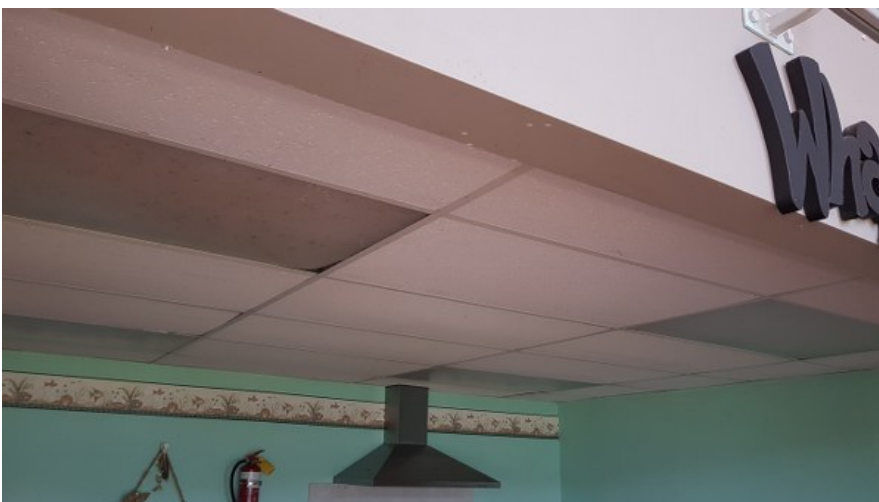
The suspended ceilings under the mezzanine floor will also need to be fire rated. This is usually done with fire line Gib board and insulation between the floor joists. The suspended ceiling can be re-installed under the FRR ceiling if desired.

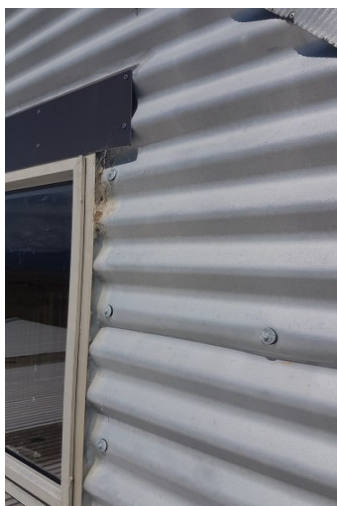
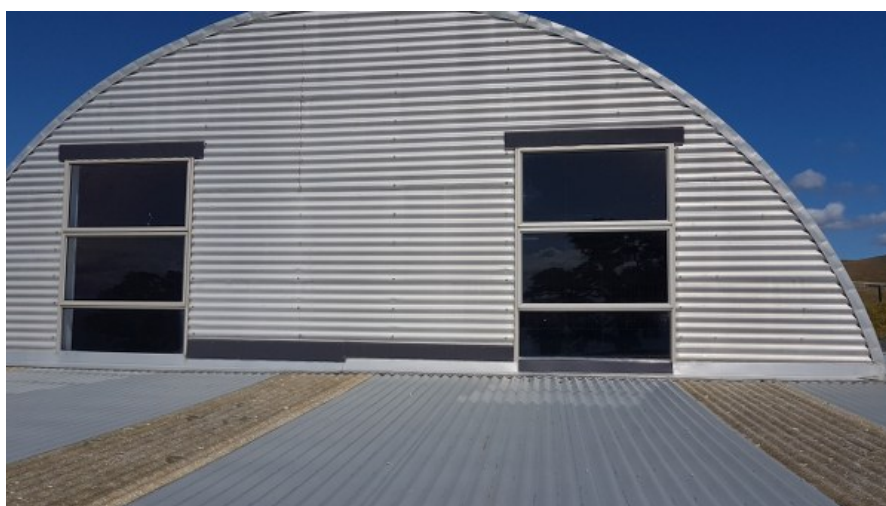
The kitchen extraction unit is not doing anything as there is no ducting to the outside or venting to the top of the unit. The duct needs to be installed along the back wall to the right outside wall. This could be concealed inside, or above wall fitted cupboards.

This building was built when it was legal to install windows without head flashings. Where the code required the owner to replace the sealants every 5 years. This was a very bad decision by the Building Industry Authority and this building has suffered constant leaks around doors and windows from this.

It is highly recommended this problem is fixed with a Registered builder installing made to size head flashing and side flashings to all doors and windows. Being a very high wind zone quality flashings are extremely important for this building.

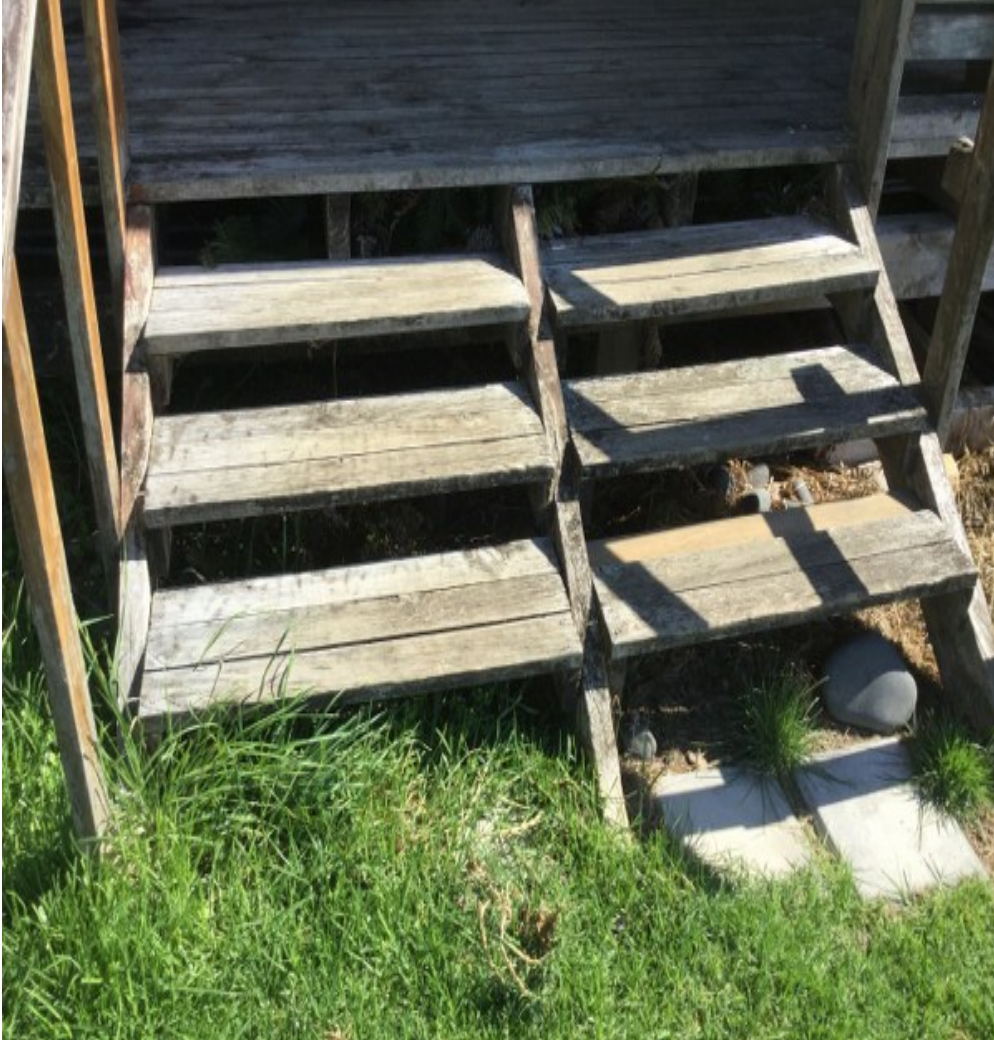
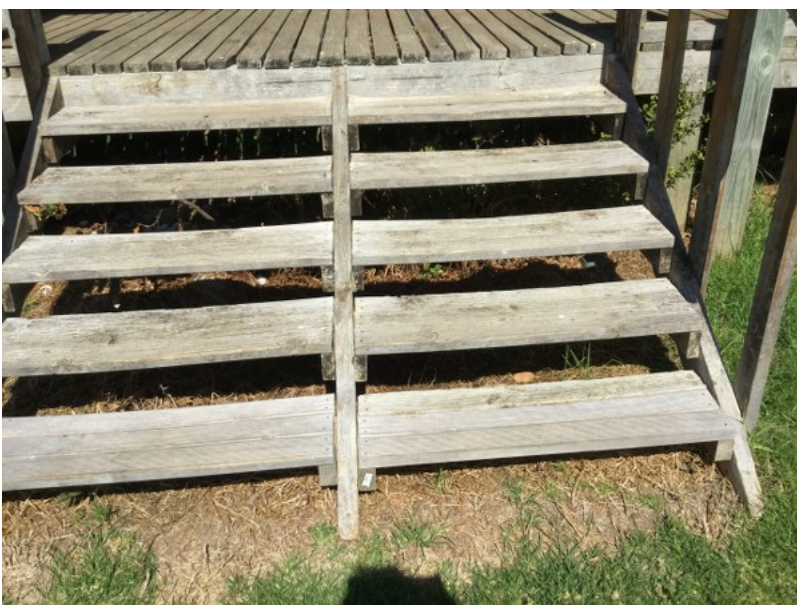
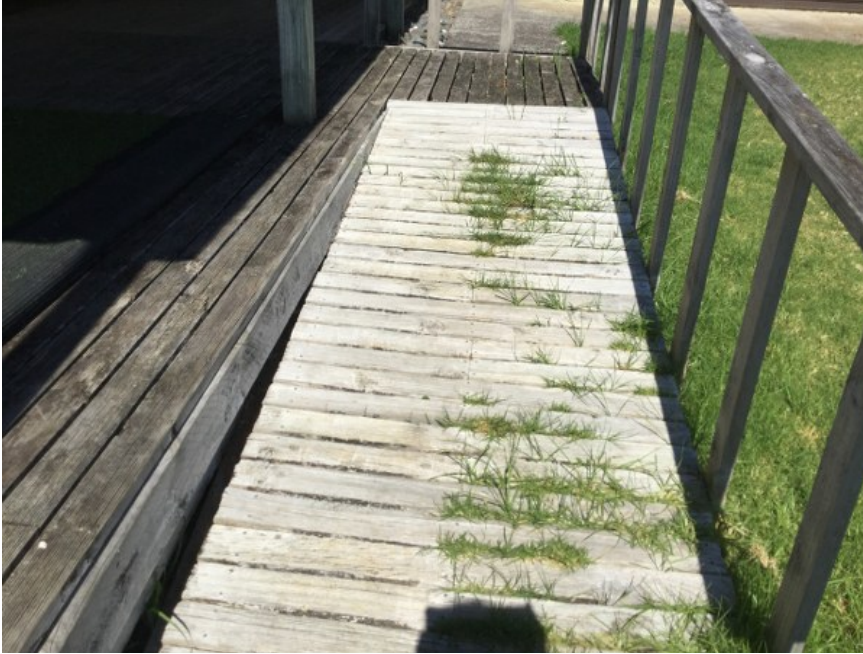
There are several short stairs to the main deck and a stair and landing for the back door to the mezzanine. The stairs to the front deck are sagging due to over span of the tread timbers. It is recommended these stairs have

The ramp decking is in poor condition and needs replacing then a Deck Seal applied.

additional runners fitted under them. The other stairs are in acceptable condition.

To ensure these stairs stay safe it is recommended the timbers are washed with “Deck Cleaner” then two coats of “Deck Seal” applied.

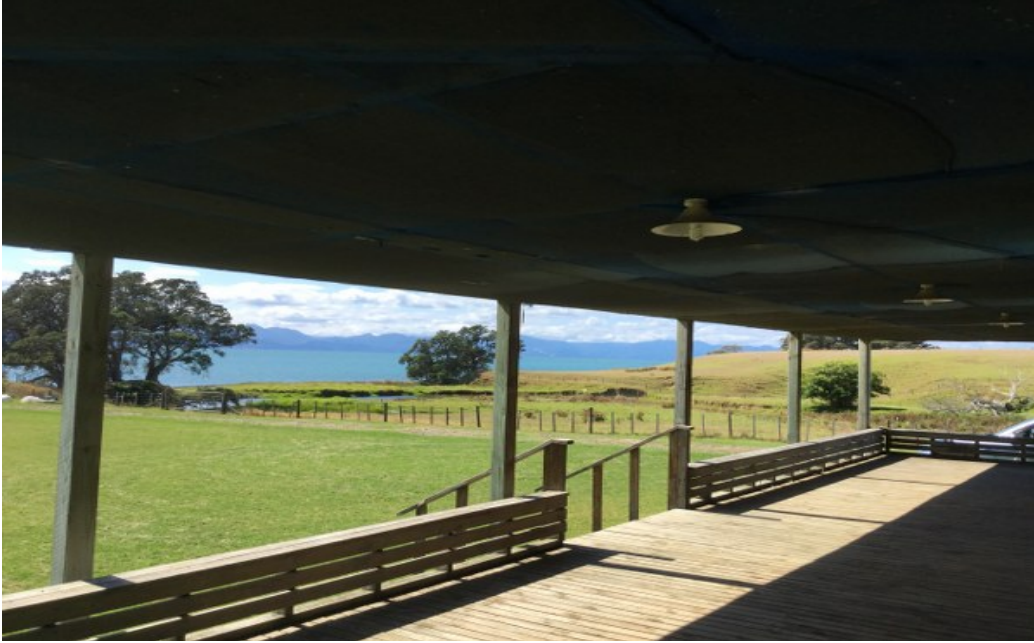
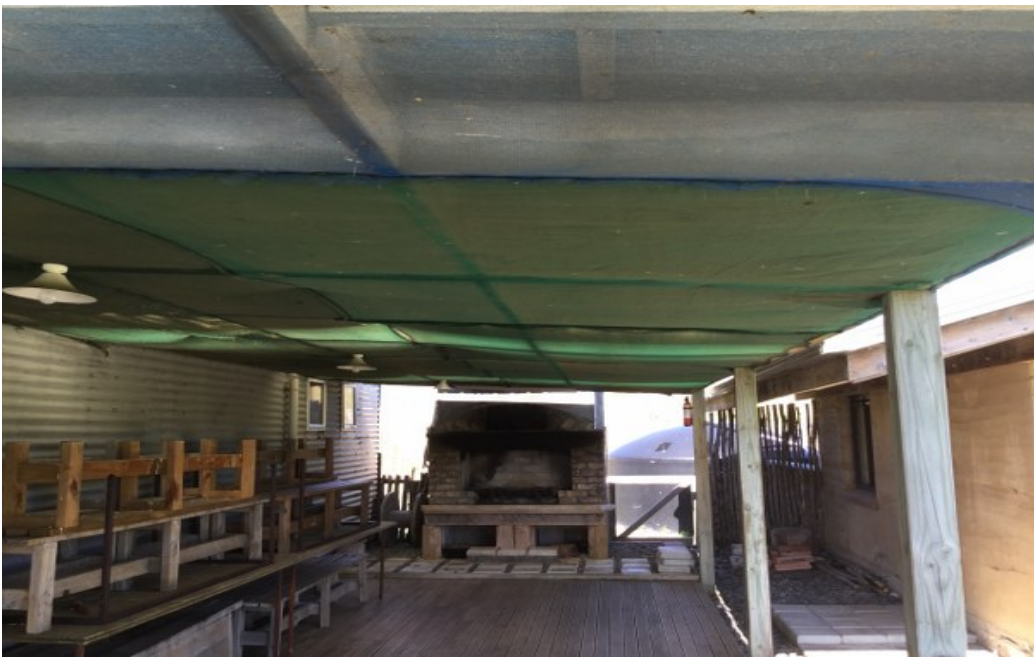
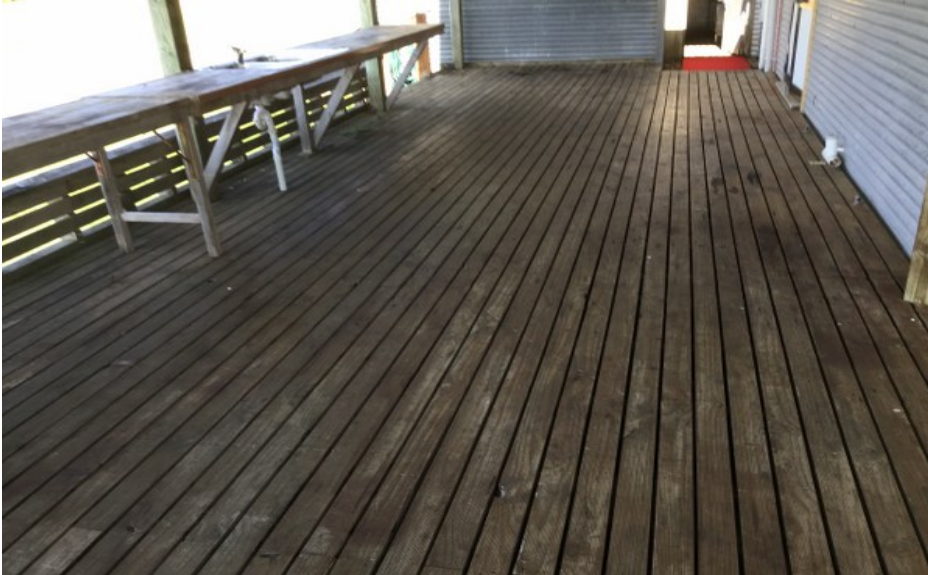
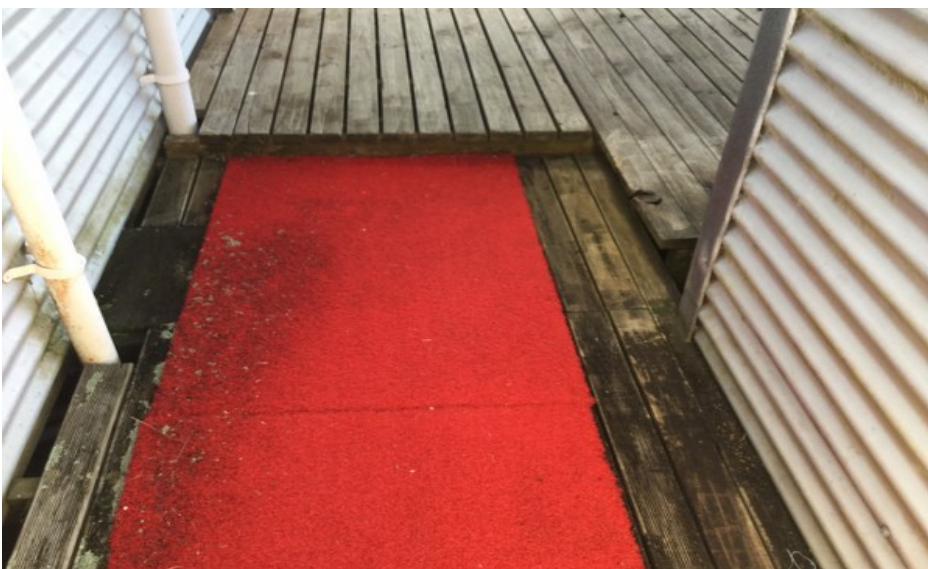
There is however a couple of sections of the deck that have been exposed to the weather and the decking timber to these areas is in poor condition. These are to the side by the ramp and the small section by the utilities shed. Some of the decking timber to these areas will need to be replaced.

The open fire unit at the end of the deck is too close to the pergola roofing. It is recommended the pergola roof is cut back to provide a safe gap from the fire.

The screening hung under the deck roof will need to be removed from nominated escape routes for prevention of fire spread of flame.

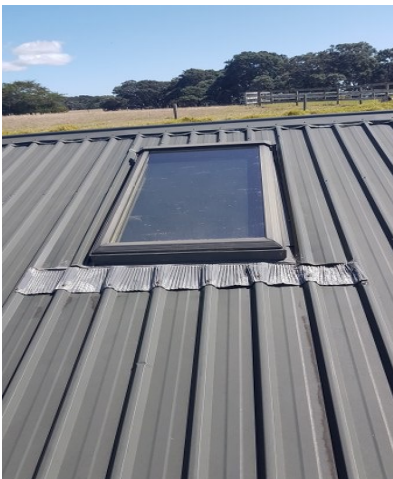
The roof is in reasonable condition but there are some areas where the roofing is lifting. The loose section of roofing need to be fixed securely down with stainless steel roofing screws. There is also moss growth to the left side of the roof. Recommend this section is prayed with a moss removing roof spray. The tank water pipes will need to be disconnected for a week or two after spraying.

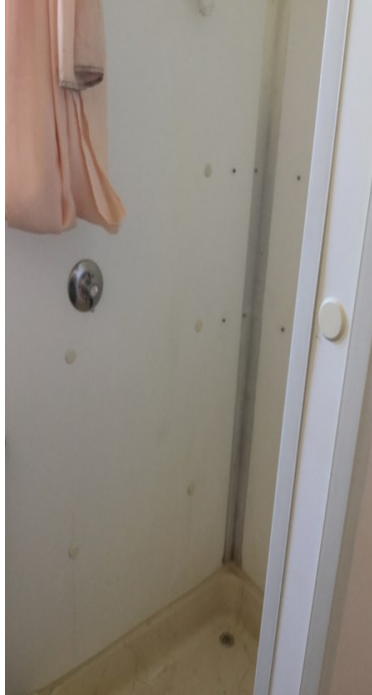
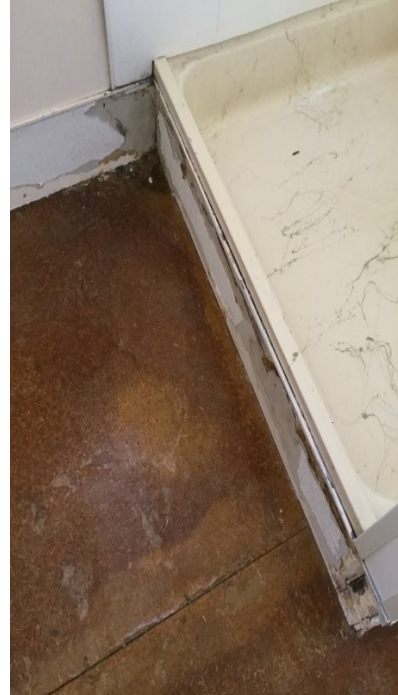
This is an area when most work is needed. The floors have been damaged and there are some wet readings to some areas. With the need to replace the flooring it is an opportunity to upgrade all the ablutions with modern and more durable facilities and surface finishes. It is also a chance to improve the layout to provide additional showers, toilets and wash basins.

All work to the ablutions will be required to be to current building code standards to ensure no future moisture damage can occur. Additional facilities will also require a building consent.
